# **Predictive Maintenance Inspection at XYZ Company**

**3/24/2008**

Infrared inspection is completed in accordance with NFPA 70B, Recommended Practices for Electrical Equipment Maintenance and NFPA 70E, Arc Flash Hazard.

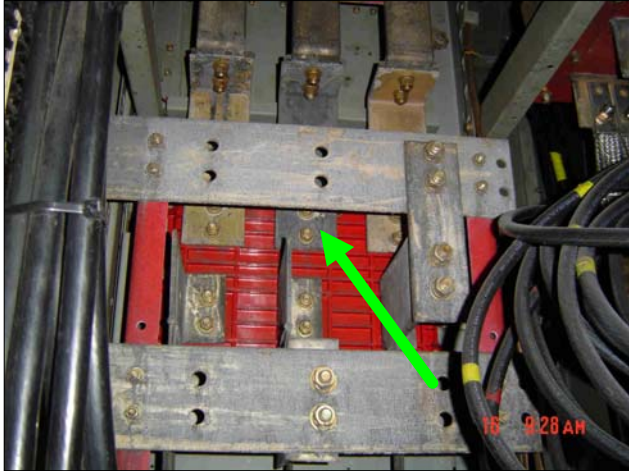
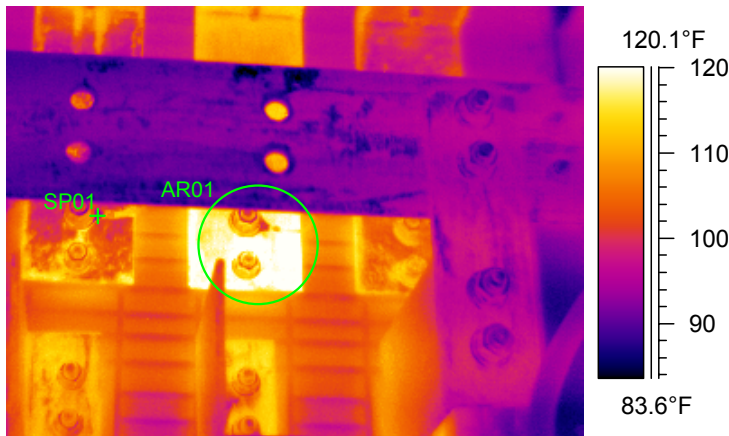
IR information	Value
Date of creation	11/14/2007
Time of creation	10:12:55 AM
IR Text Comment	Value
Section	Distrib. Sw. Gear 3
Equipment	Mains
Fault	B ph. loose bolted joint
Add. info.	Reference A ph.
Recommendation	Clean and retorque
Fault severity	2
Object parameter	Value
Ambient temperature	79.0°F
Label	Value
SP01	93.8°F
AR01 : max	131.1°F

Notes: The B phase bolted joint shows increased resistance at the bolted joint. There are signs of corrosion on some of the buss bars which could also cause the increase resistance. Remediate by cleaning the surfaces and retorquing the joint.

**Clean and retorque**

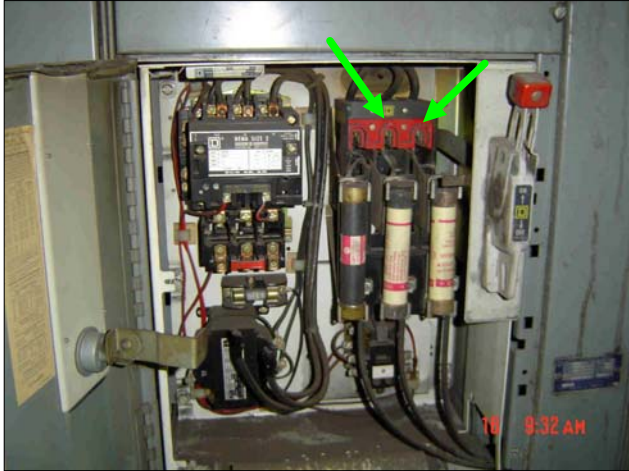
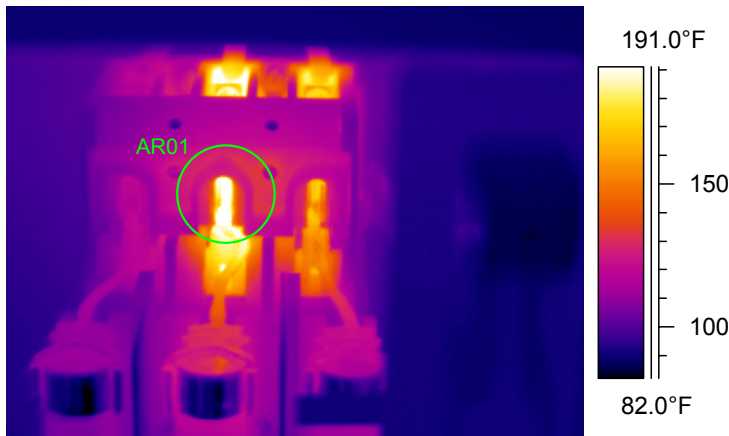
IR information	Value
Date of creation	11/14/2007
Time of creation	10:29:55 AM
IR Text Comment	Value
Section	Foundry
Equipment	Forced draft blwr disc.
Fault	B & C ph. failed contact
Add. info.	none
Recommendation	Replace
Fault severity	1
Object parameter	Value
Ambient temperature	87.0°F
Label	Value
AR01 : max	220.4°F

Notes: The failed sliding contact represents an immediate hazard.

**Replace**

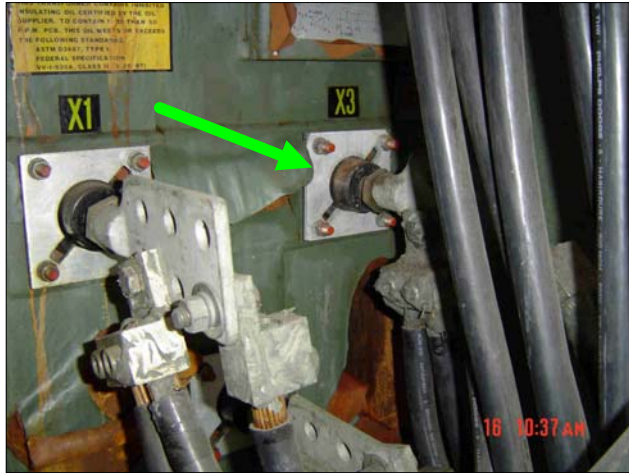
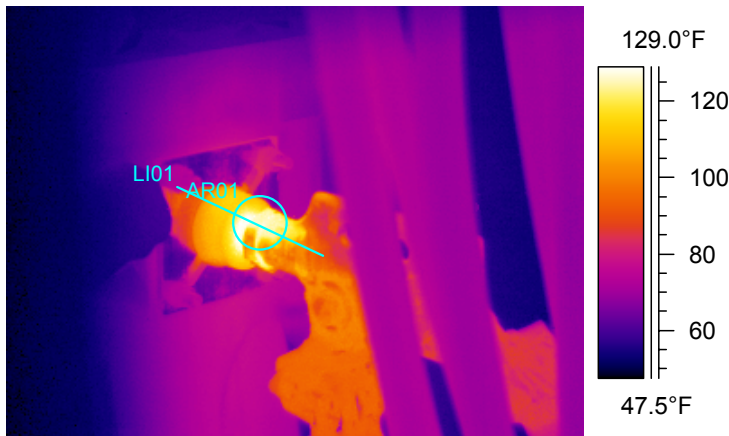
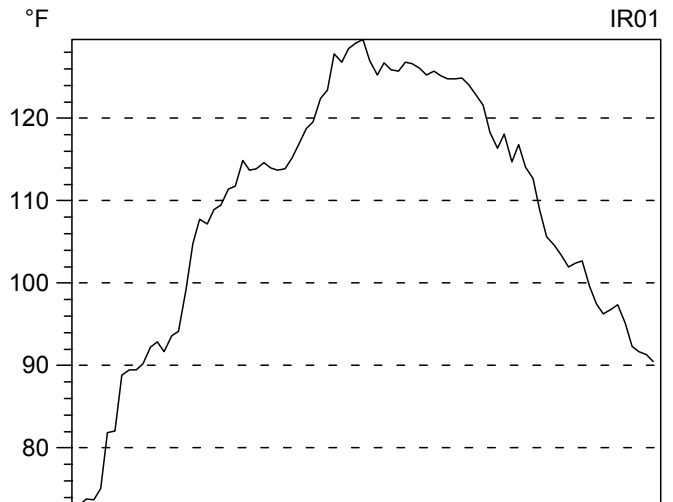
IR information	Value
Date of creation	11/14/2007
Time of creation	2:22:25 PM
IR Text Comment	Value
Section	Yard Vault
Equipment	Compressor XFMR
Fault	X3 Loose bolted joint
Add. info.	Note discoloration
Recommendation	Clean and refit
Fault severity	2
Object parameter	Value
Ambient temperature	50.0°F
Label	Value
LI01 : max	129.6°F
AR01 : max	176.5°F

Notes: Note that the maximum temperature occurs at the midpoint of line LO1 which correlates to the bolted joint. There are signs of corrosion.

### Clean and refit
